Title: Product weathertightness testing of a sample of Gebrik Walling

Report No: N950-11-16439

Client: Isosystems, Malmedyer Weg, 62, B-4770 AMEL/SCHOPPEN

Issue date: 10 November 2011

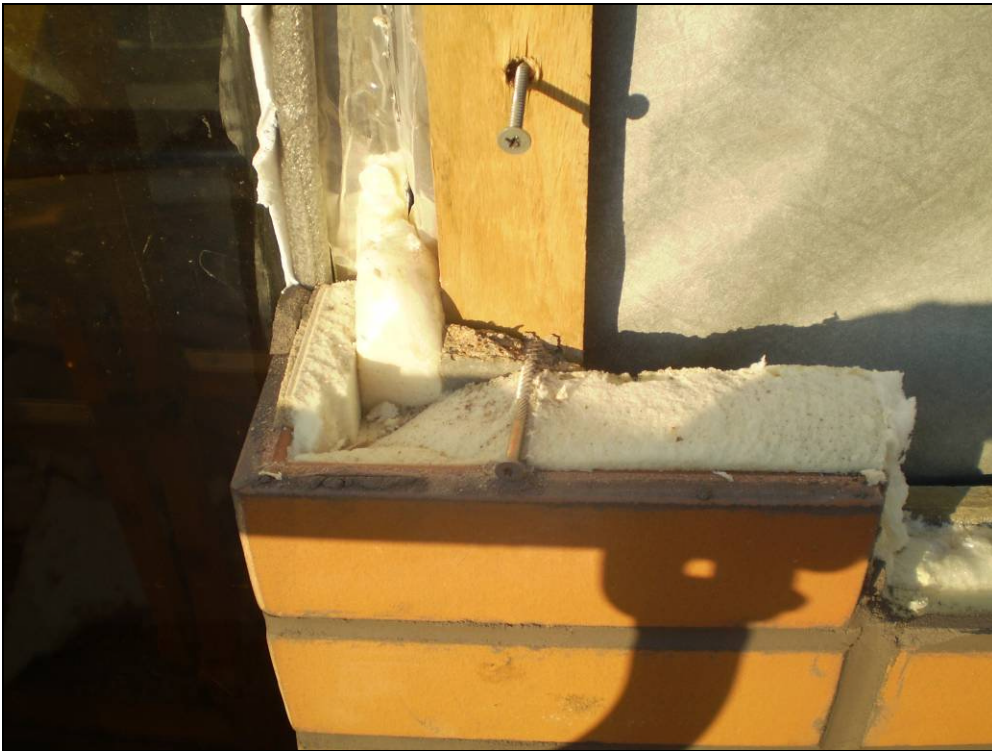
PHOTO 9300028

During the dismantling of the sample no water penetration or discrepancies from the drawings were found in the Gebrik system. At the base of the sample a small quantity of foam sealant had been applied in a couple of locations where water had been observed.

CORNER DETAIL

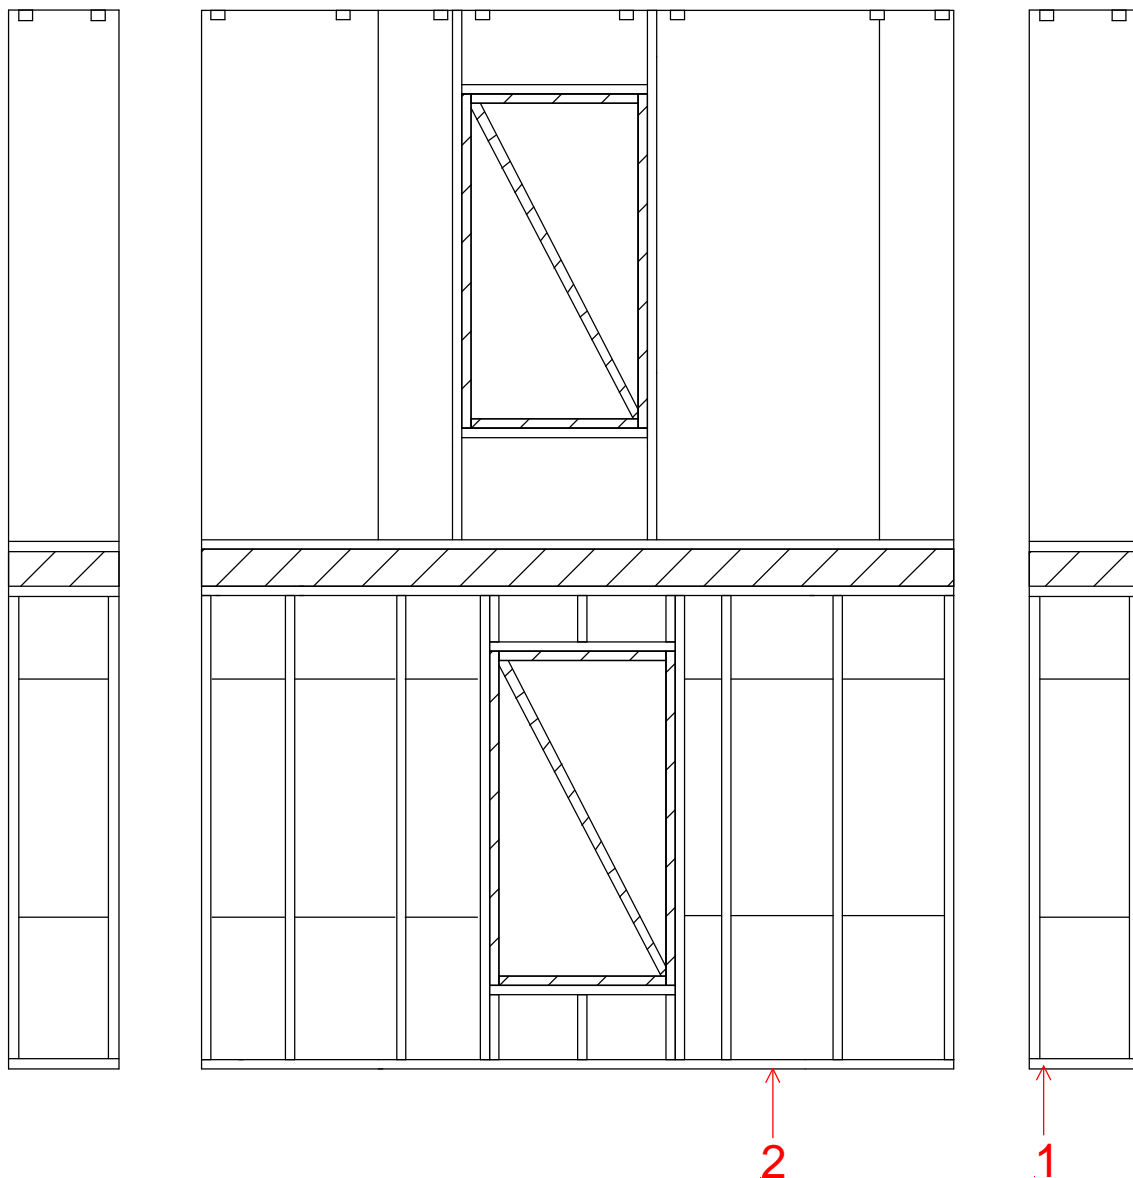
FIGURE 5

After 1 minute at a pressure differential of 450 pascals, water was observed at the base of from a redundant fixing hole in the base of the Metsec frame at location 1 in Figure 5.

After 4 minutes at a pressure differential of 600 pascals water was also observed ponding from a joint in the bottom the Metsec frame at location 2 in Figure 5.

Note: These leaks were not through the Gebrik system but the base perimeter seal to the test chamber. The base support steelwork projected passed the front face of the Gebrik allowing water to pool along the base and was not as shown in the drawings attached to the appendix.

After 1 minute at a pressure differential of 600 pascals water was observed ponding in the base of the return at location 1 in Figure 5.

Note: This leak was not through the Gebrik system but the base perimeter seal to the test chamber.

The hole was sealed over in location 1 and the joint in the Metsec frame sealed over in location 2. Additional foam sealant was applied at the base of the sample at these locations only.

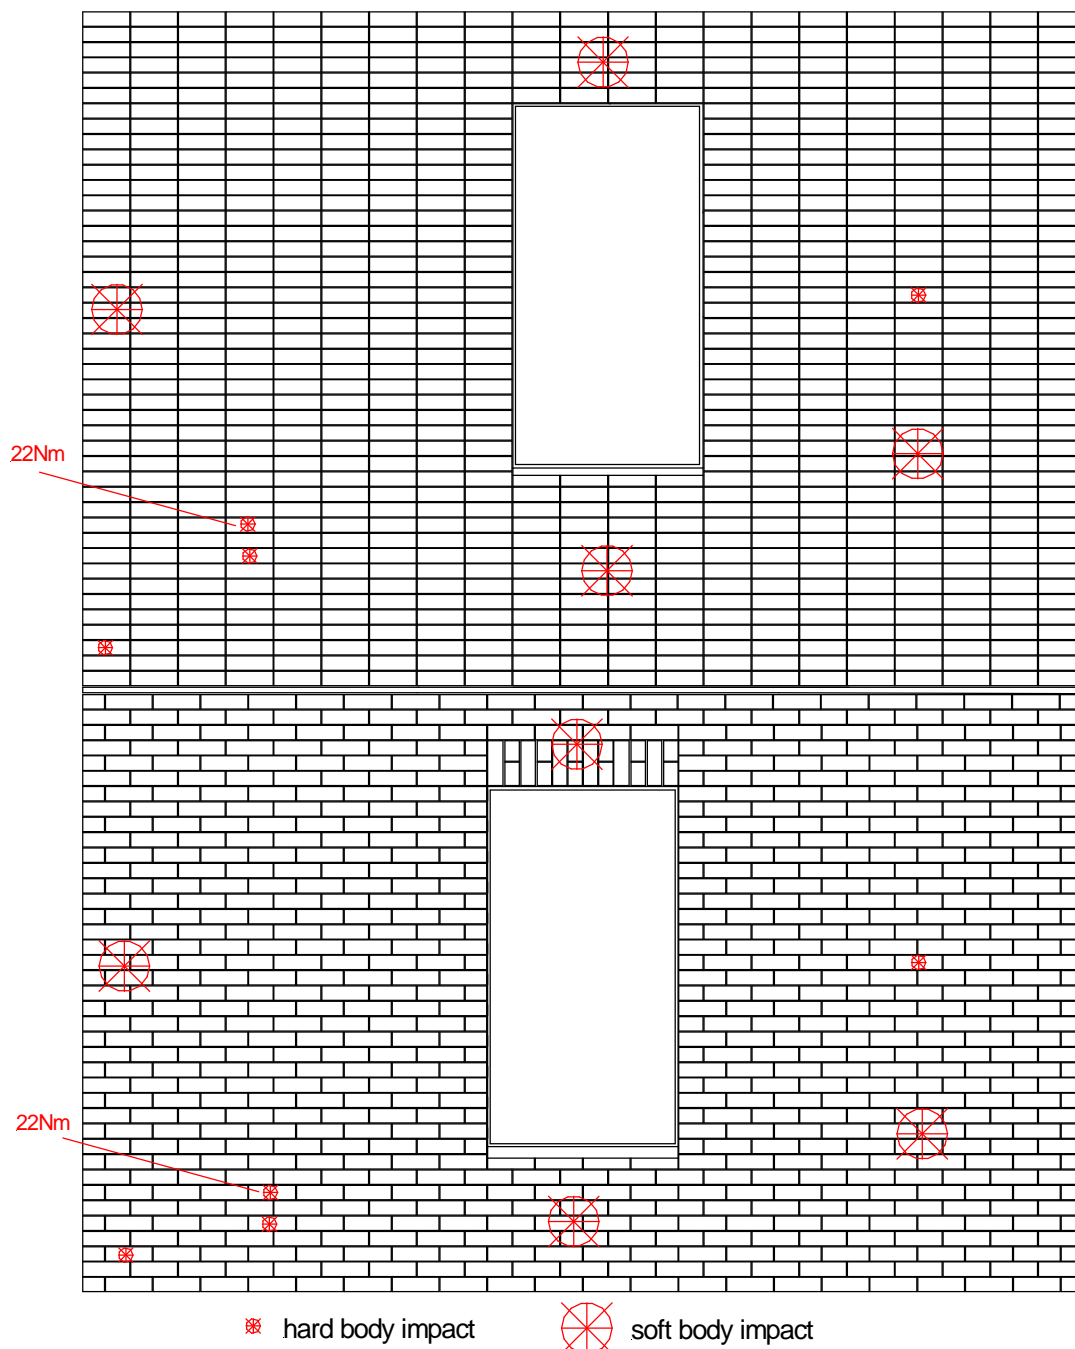
FIGURE 7

During the soft body impact testing, with a serviceability energy of 120 Nm, no damage to the sample was observed.

During the hard body impacts, including two at 22 Nm energies, no damage to the sample was observed.

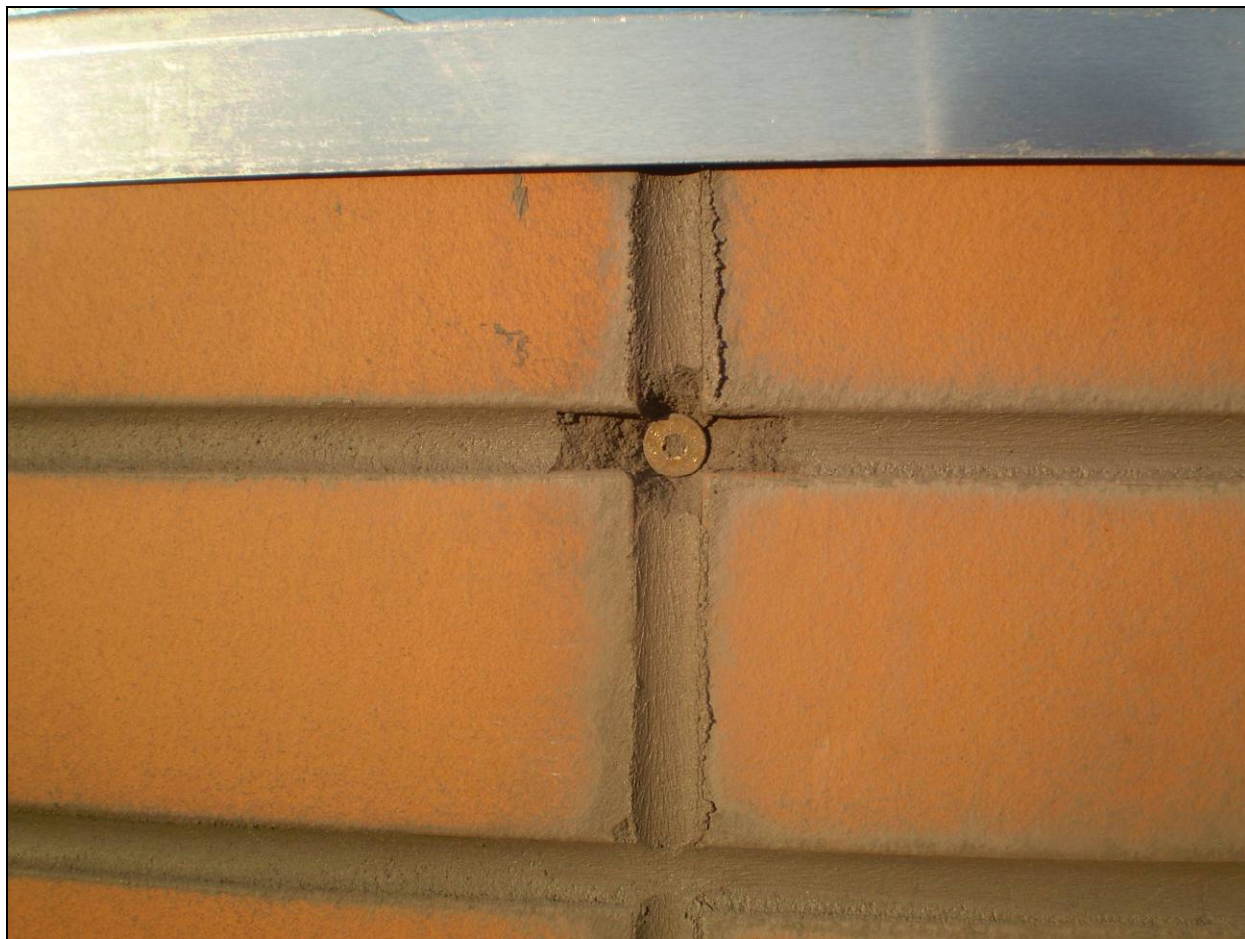
PHOTO 930032

hours prior to testing and was not fully cured). There were also minor cracks in the mortar joints next to the impacts.

GEBRIK FIXING SCREW REVEALED AFTER 500 NM IMPACT
