Title: Product wind resistance, dynamic watertightness and impact resistance testing of a Mechsliip Façade for Ash & Lacy

Report No: N950-19-17772

Customer: Ash & Lacy, Bromford Lane, West Bromwich
West Midlands, B70 7JJ

Issue date: 03 October 2019

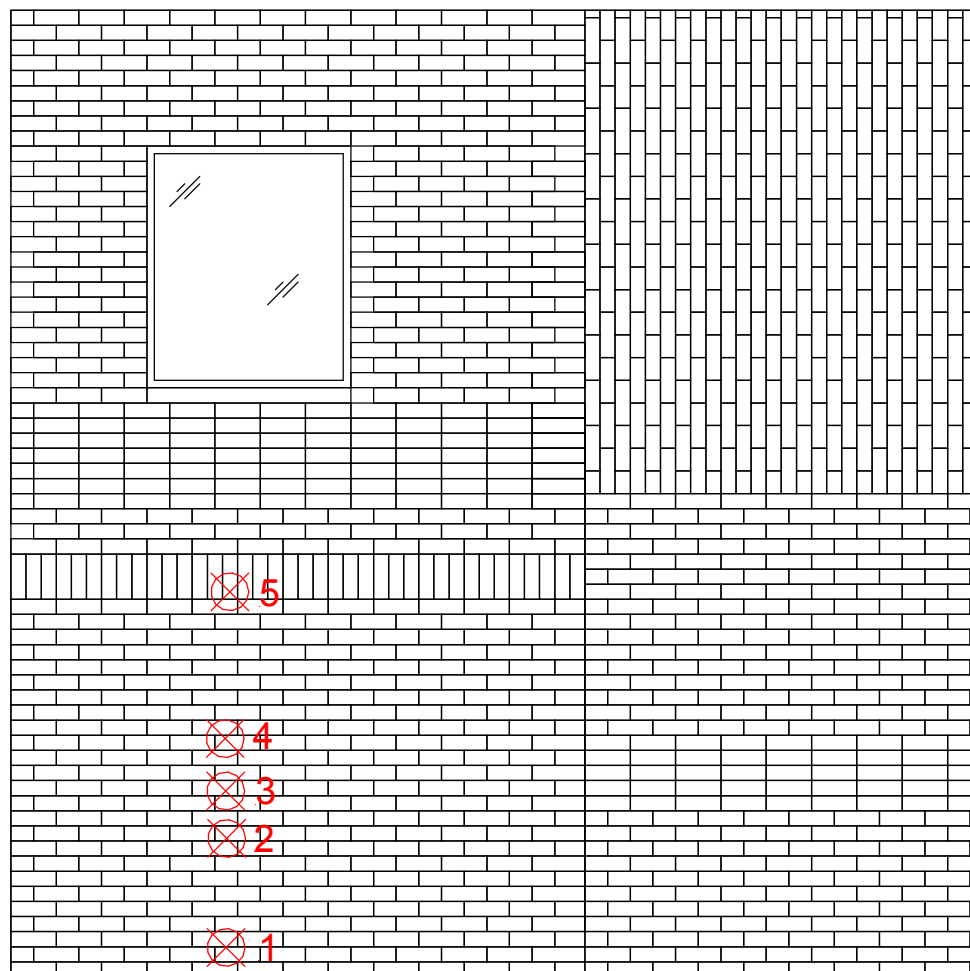
DEFLECTION GAUGE LOCATIONS

No damage to the test sample was observed.

No damage to the sample was observed.

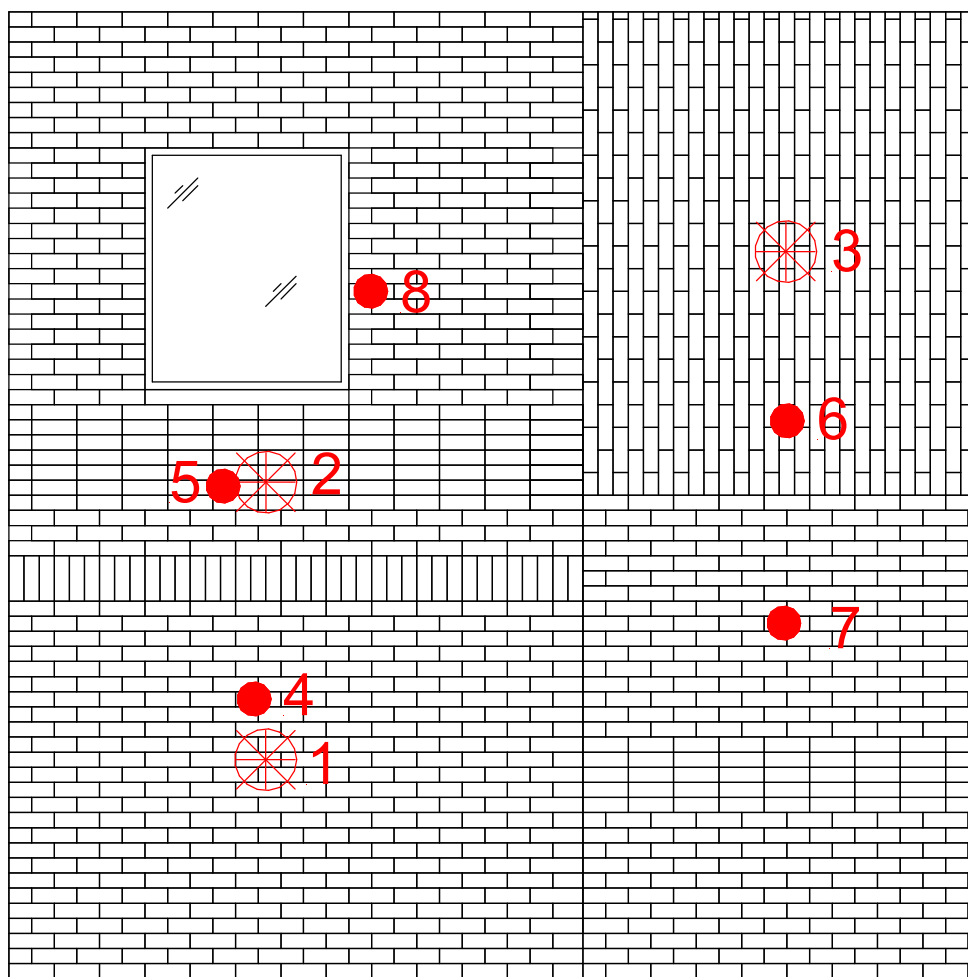
IMPACT TEST LOCATIONS

Impact location	Impact energy (Nm)	Observations	Classification
1	120 x 3 350 500	No damage observed No damage observed No damage observed	Class 1 Negligible risk Negligible risk
2	120 x 3 350 500	No damage observed No damage observed Minor mortar cracks	Class 1 Negligible risk Negligible risk
3	120 x 3 350 500	No damage observed No damage observed No damage observed	Class 1 Negligible risk Negligible risk
4	3 6 10	No damage observed Minor crack in mortar Minor crack in mortar	Class 1 / Negligible risk Class 1 Class 1 / Negligible risk
5	3 6 10	Minor crack in mortar Minor crack in brick No damage observed	Class 1 / Negligible risk Class 1 Class 1 / Negligible risk
6	3 6 10	No damage observed No damage observed Small crack in corner of brick	Class 1 / Negligible risk Class 1 Class 1 / Negligible risk
7	10	Small crack in brick surface	Class 1 / Negligible risk
8	10	Crack in brick return	Class 2 / Negligible risk
