Title: Product wind resistance, dynamic watertightness and impact resistance testing of a NaturAL-X Façade for Ash & Lacy

Report No: N950-19-17790

## **NaturAL-X CWCT Test Set Up And Procedure**

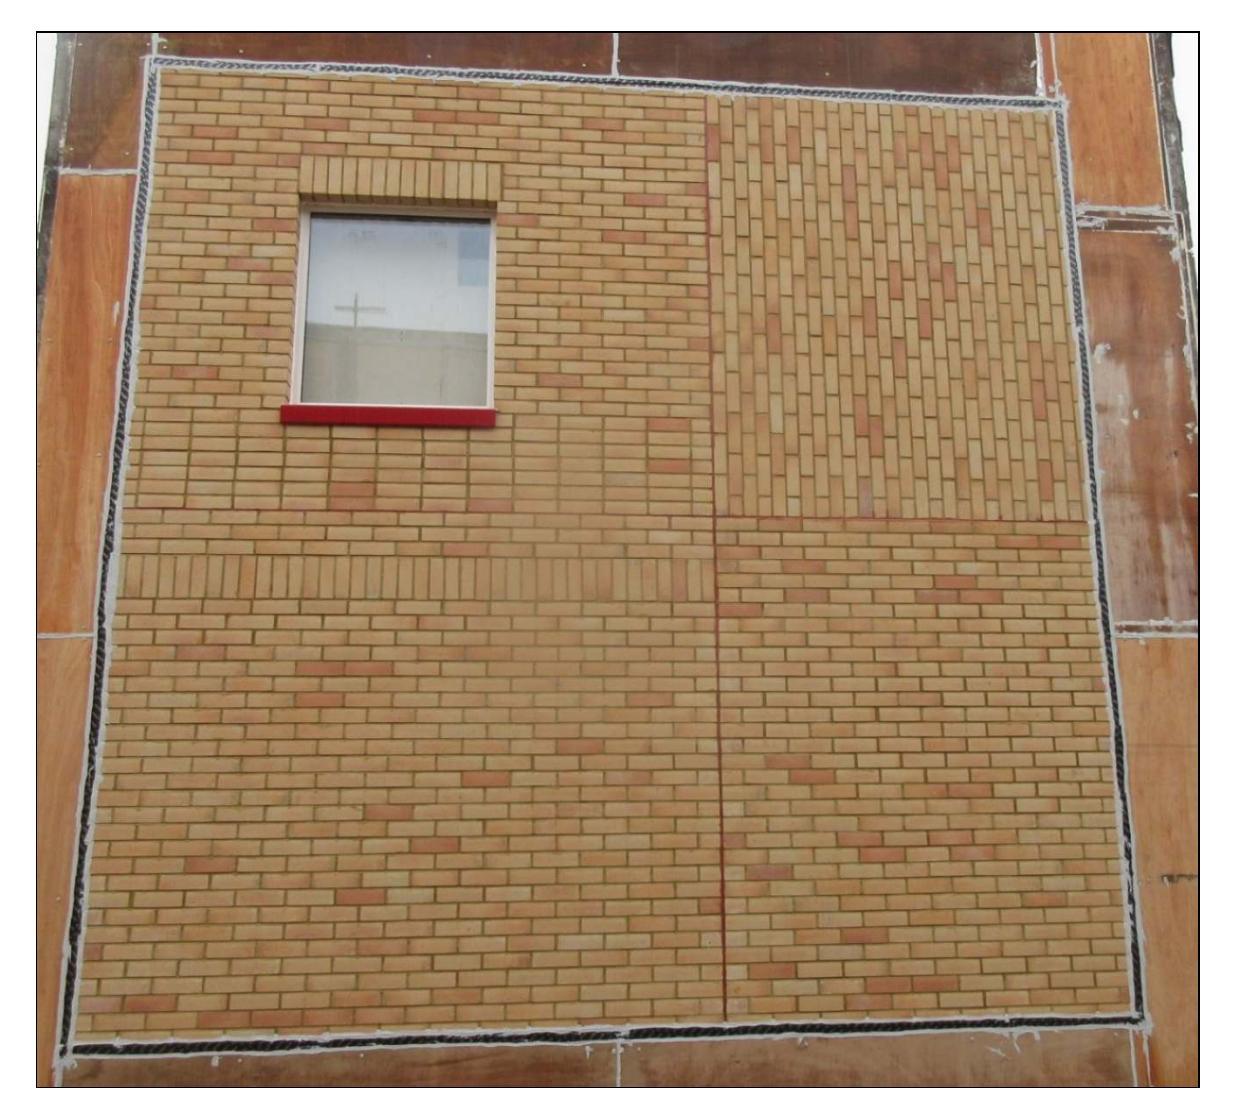
PHOTO 0569

## TEST SAMPLE ELEVATION

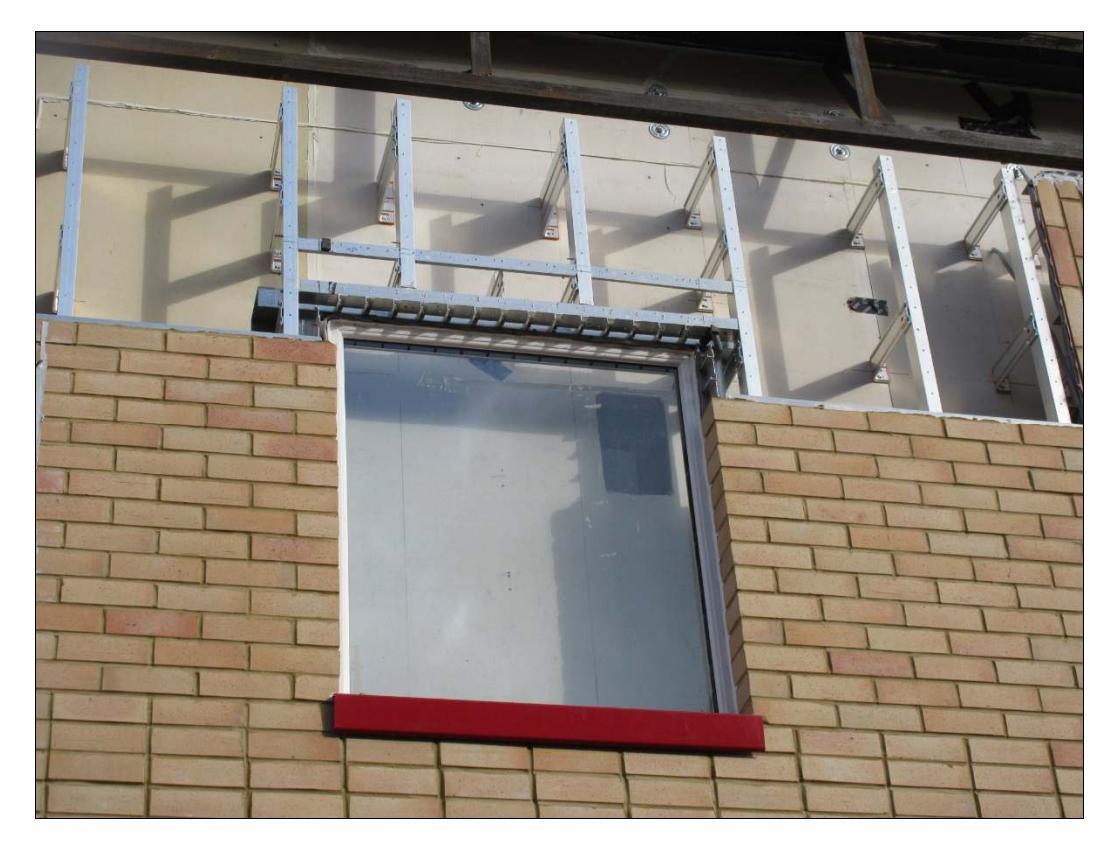
**PHOTO 0905**

During the dismantling of the sample no discrepancies from the drawings were found.

VIEW IN CAVITY

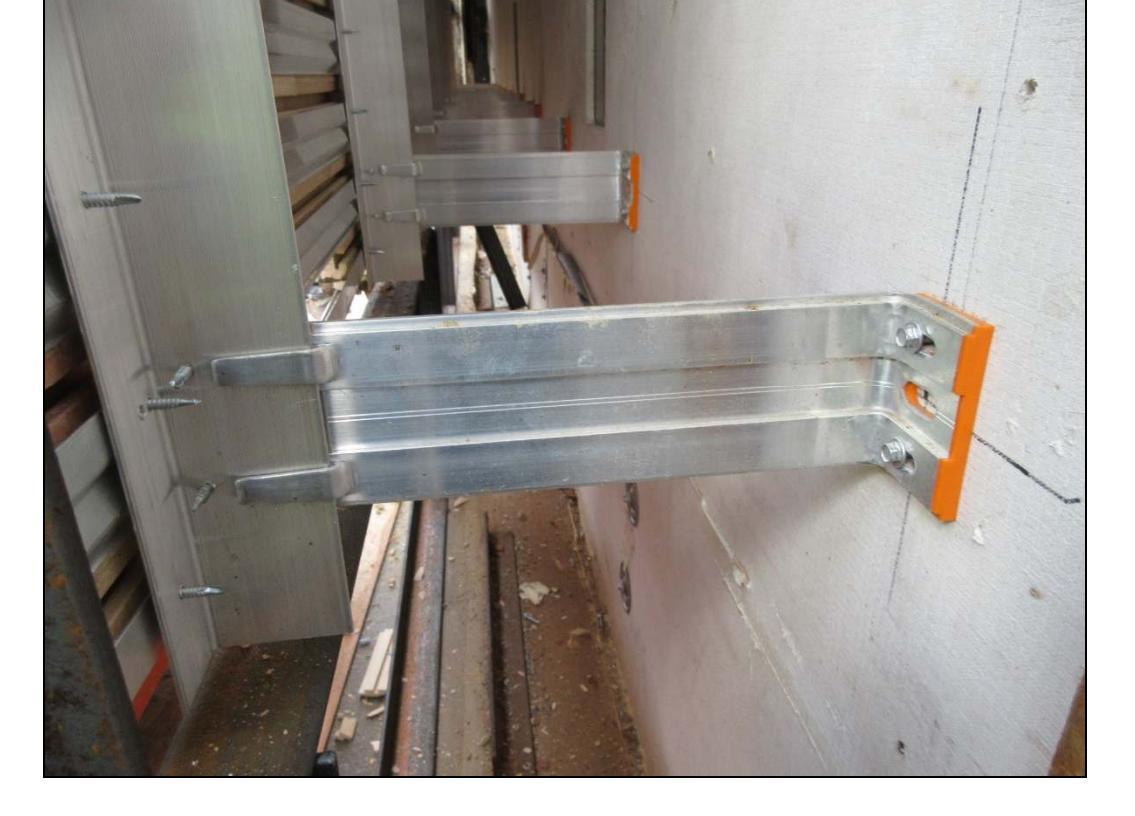
PHOTO 0907

SUPPORT BRACKET

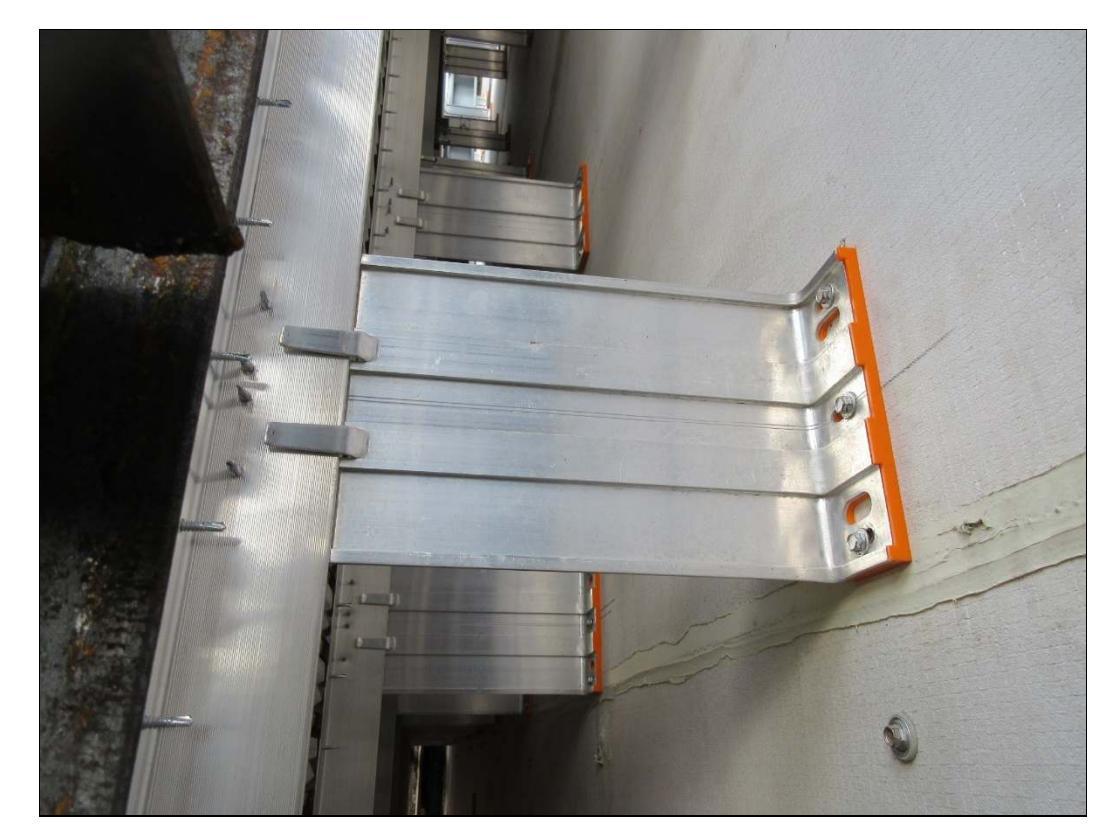
PHOTO 0906

## SUPPORT BRACKET

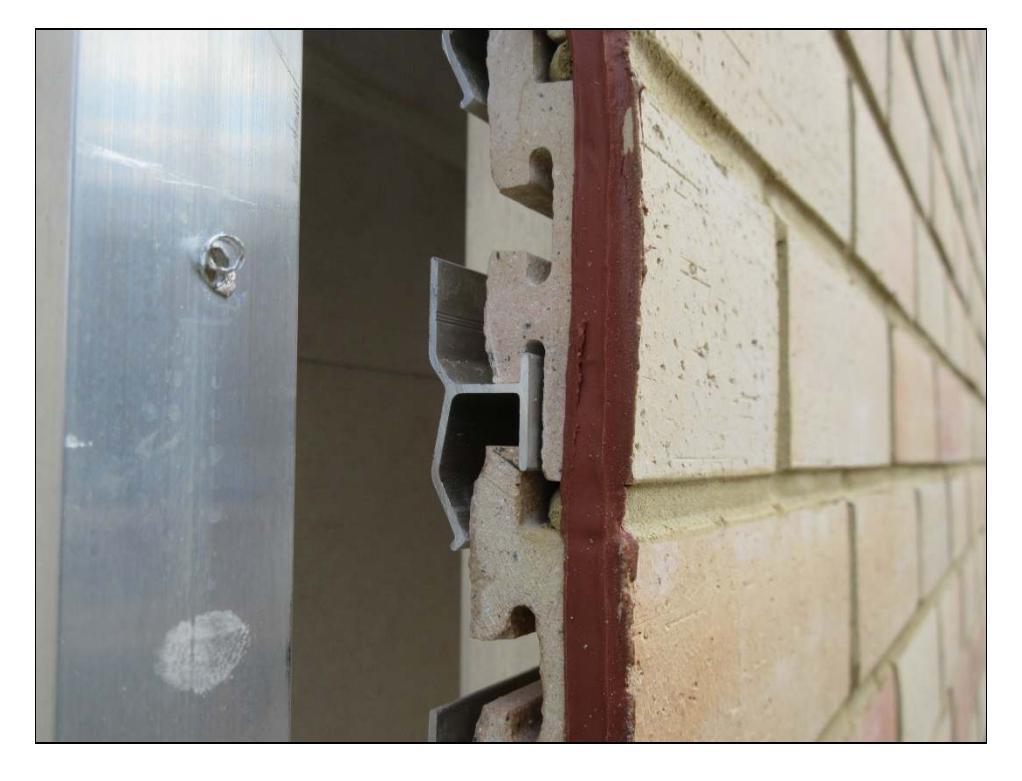
PHOTO 00911

## TEST SAMPLE DURING DISMANTLE

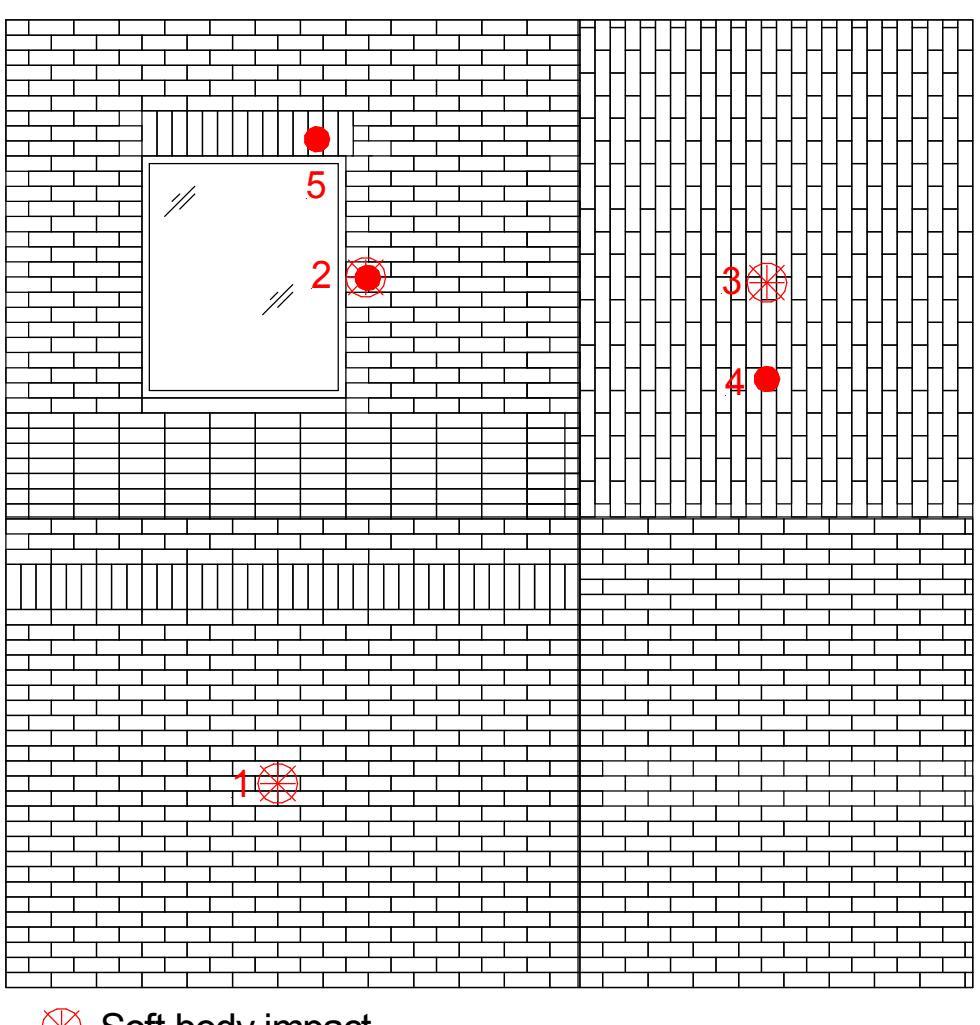
FIGURE 3

## **IMPACT TEST LOCATIONS**

Impact location	Impact energy (Nm)	Observations	Classification
1	120 x 3	No damage observed	Class 1
	350	No damage observed	Negligible risk
	500	Minor mortar cracks	Negligible risk
	3	Mark on surface	Class 1 / Negligible risk
	6	Mark on surface	Class 1
	10	Minor mortar cracks	Class 1
2	120 x 3	No damage observed	Class 1
	350	No damage observed	Negligible risk
	500	Minor mortar cracks	Negligible risk
	10	Mark on surface	Class 1 / Negligible risk
3	120 x 3	No damage observed	Class 1
	350	No damage observed	Negligible risk
	500	Minor mortar cracks	Negligible risk
4	3	Mark on surface	Class 1 / Negligible risk
	6	Mark on surface	Class 1
	10	Minor mortar cracks	Class 1 / Negligible risk
5	10	Mark on surface	Class 1 / Negligible risk

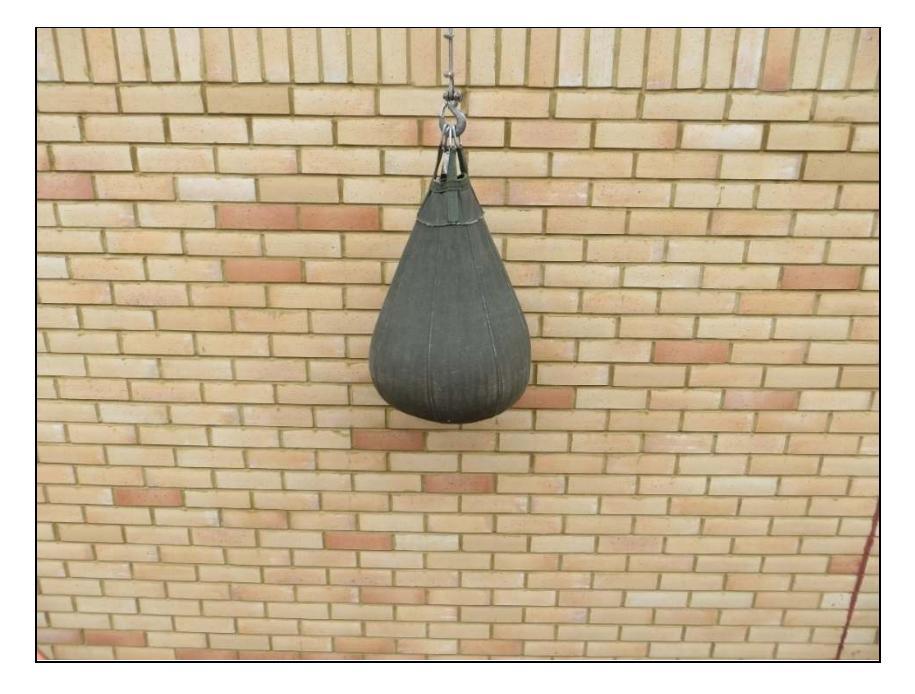
PHOTO 0228

#### SOFT BODY IMPACT

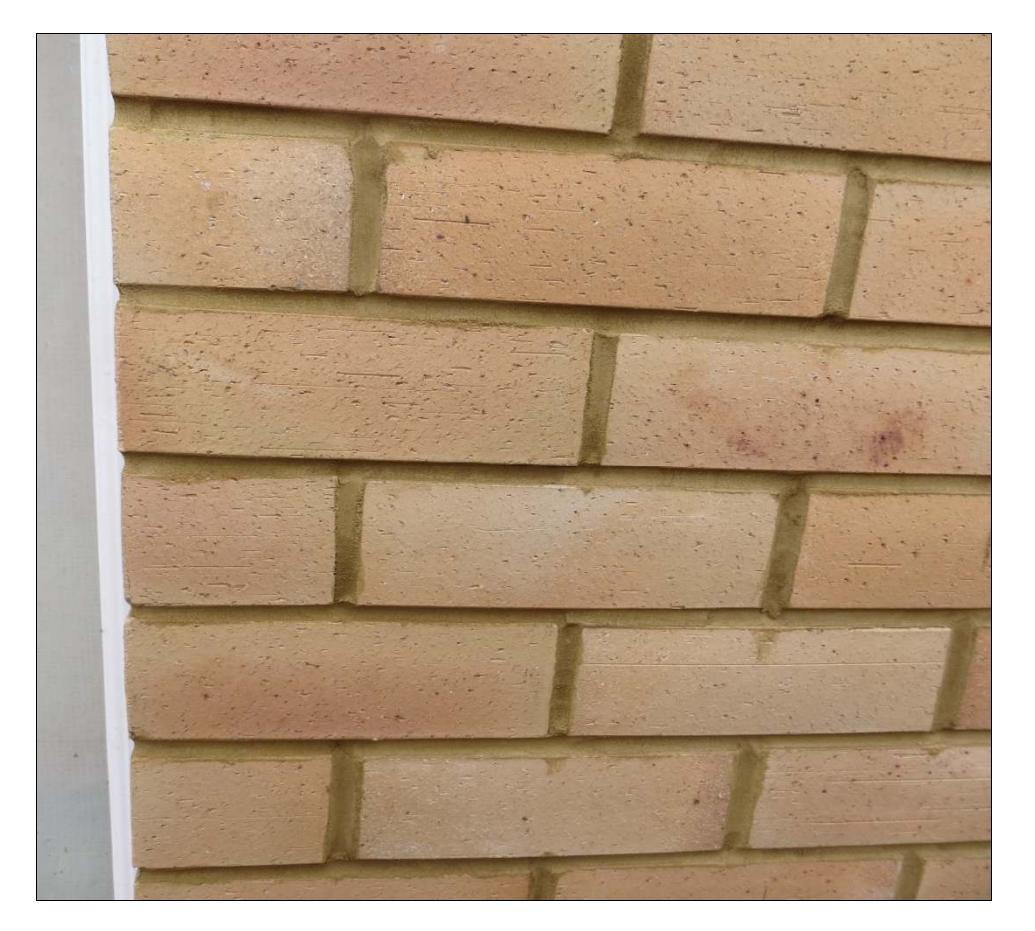
**PHOTO 0231**

## SOFT BODY IMPACT

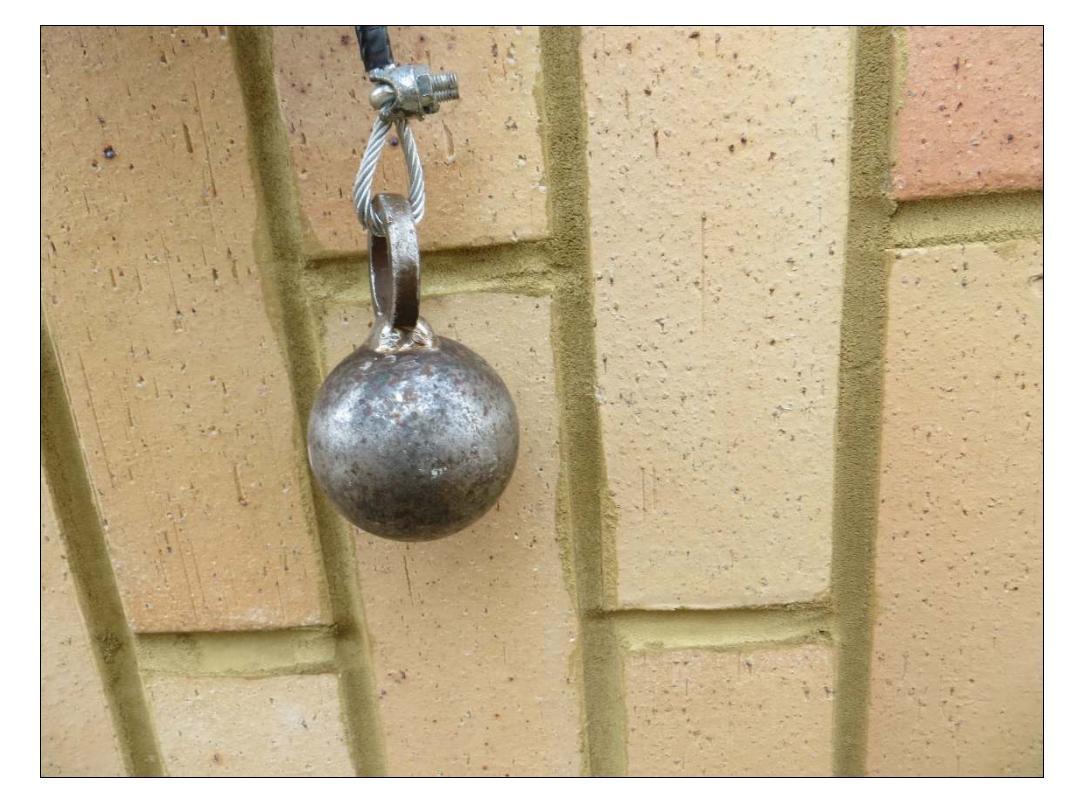
**PHOTO 0235**

## HARD BODY IMPACT

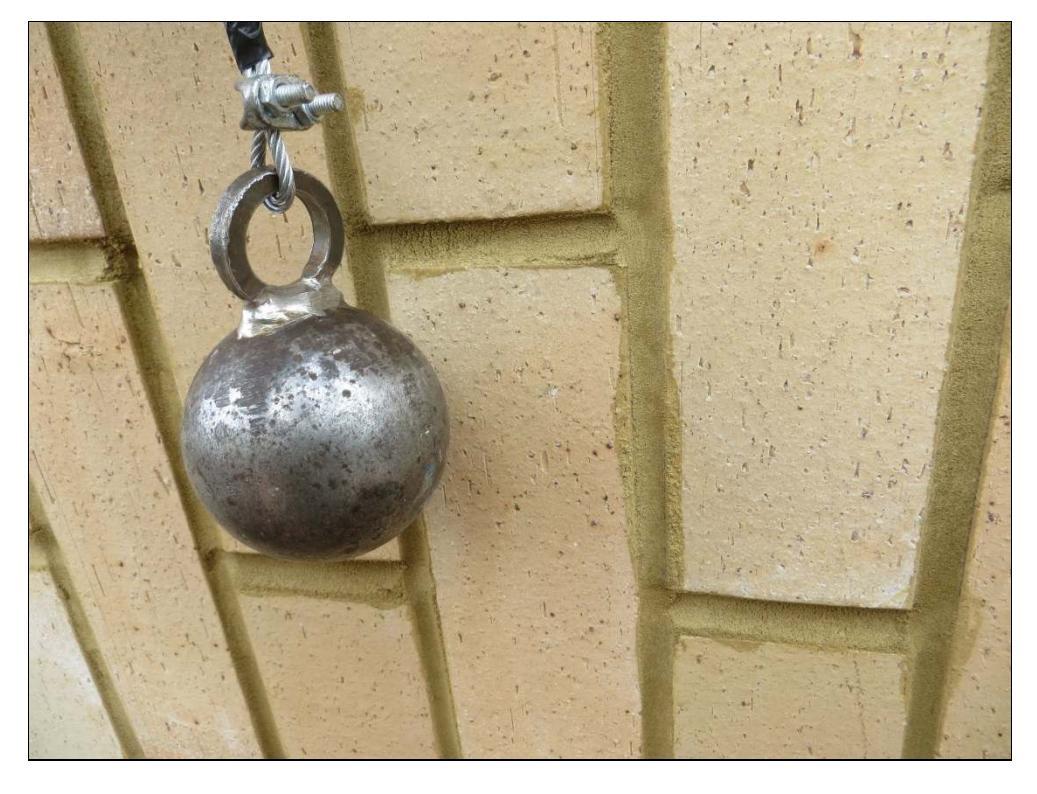
**PHOTO 0241**

## HARD BODY IMPACT
