Title: Product weathertightness testing of a sample of Gebrik Walling

Report No: N950-11-16439

Client: Isosystems, Malmedyer Weg, 62, B-4770 AMEL/SCHOPPEN

Issue date: 10 November 2011

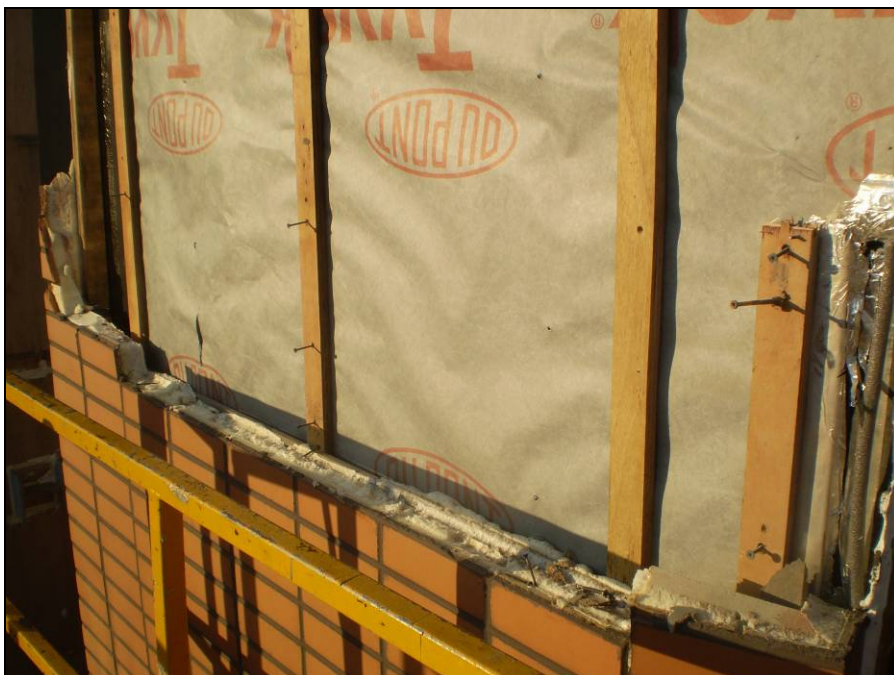
PHOTO 9300031

During the dismantling of the sample no water penetration or discrepancies from the drawings were found in the Gebrik system. At the base of the sample a small quantity of foam sealant had been applied in a couple of locations where water had been observed.

UPPER GEBRIK PANELS REMOVED

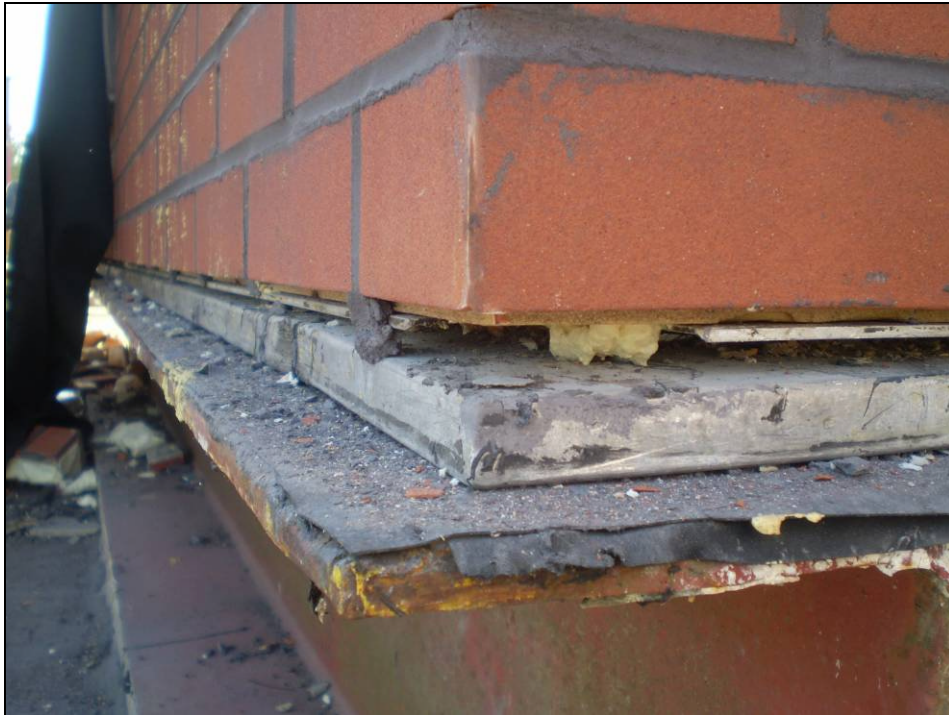
PHOTO 9300054

CORNER VIEW AT BASE OF SAMPLE

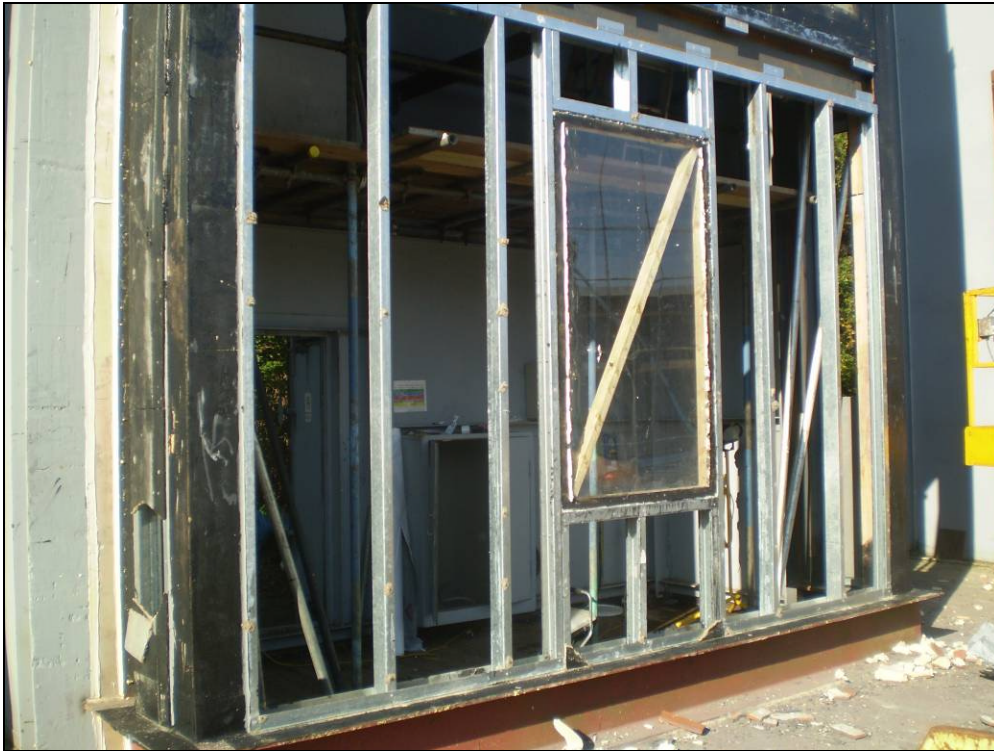
PHOTO 9300065

METSEC FRAME AT LOWER LEVEL OF SAMPLE

After 1 minute at a pressure differential of 450 pascals, water was observed at the base of from a redundant fixing hole in the base of the Metsec frame at location 1 in Figure 5.

After 4 minutes at a pressure differential of 600 pascals water was also observed ponding from a joint in the bottom the Metsec frame at location 2 in Figure 5.

Note: These leaks were not through the Gebrik system but the base perimeter seal to the test chamber. The base support steelwork projected passed the front face of the Gebrik allowing water to pool along the base and was not as shown in the drawings attached to the appendix.
